# THE IMPACT OF CLIMATIC FACTORS ON DAMPNES IN UNIVERSITY ACCOMMODATIONS: A CASE STUDY ANALYSIS

Abidin, Z. Z., Ahmad, N. A., Rijal, N. S., Rased, A. N. N. W. A., Abdullah, W. N. H. W. (2025). The Impact Of Climatic Factors On Dampness In University Accommodations: A Case Study Analysis. *International Journal of Innovation and Industrial Revolution*, 7 (21), 240-260.

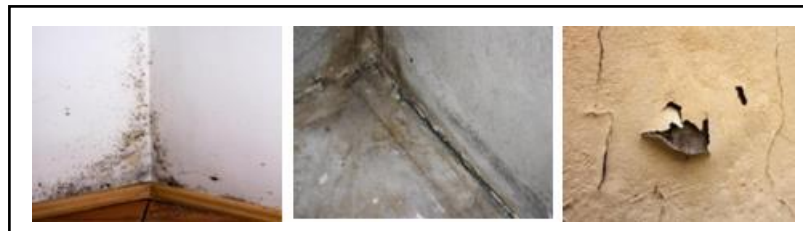
**Figure 2: The Building Defects Associated With Dampness**

The moisture problem that occurs in the buildings is usually take place on the at connection between the floor and the wall of a building (see Figure 1 and 2). The occurrence of water seepage that is related to improper waterproofing installation or deterioration of damp proof course (DPC) may lead to mould growth, flaking of paint and water stain (Luca, 2014).

One of the highest humidity areas in the building is the toilet (Jamaludin et al., 2015) (Kwag et al., 2019). The water seepage from the toilet areas can also affected the internal wall buildings. The peeling paint and blistering of wallpaper finishes occurred due to failure of water proofing layers on the toilet wall that caused water to penetrate through the toilet wall and affect the perimeter wall as shown as in Figure 2.

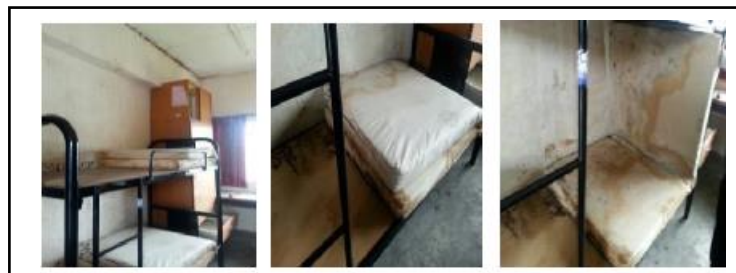
**Figure 6: Example Taken From A Pilot Study Of This Study: Cempaka Sari Colleges, UiTM Perak.**

All photos related come from rooms that are located next to the toilet (see Figure 6). It is significant to carry out this research based on the proof shown, where the defect is due to a fungus attack because of high humidity. All buildings have visible water stains on the wall surface, patchy surfaces, and flaking paint.

The capacity for each block is around 615 students occupying at the same time. Most of the defects usually happen in the area of the toilet and the external area of the blocks, which involves many types of dampness. However, through the observation stage, it is found that the high occurrence of dampness in the pilot study is rising damp.

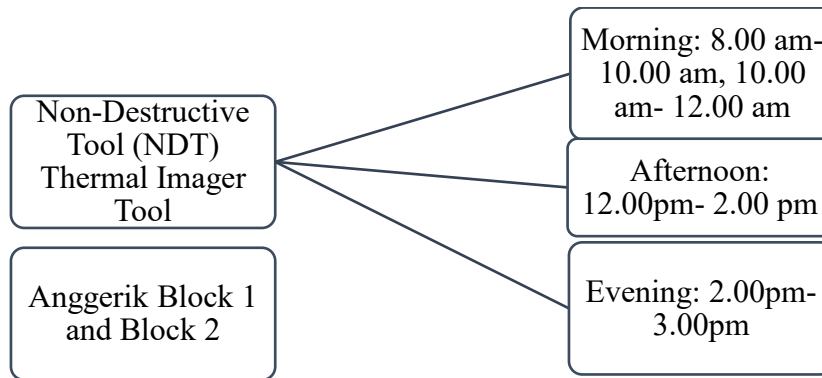
**Figure 10: Defect Matrix For The Case Study Based On NDT (Thermal Imager tool)**

Defect matrix provided in this section are the results that have been collected from the case study for all levels of the case studies building by using NDT (Thermal Imager) tool. The defect profiling grid in table 4.4 have been applied for each Thermal Imager readings that have been collected on site. Readings from grid G1A and G8B have been shown in this research as a benchmark (based on the condition of dampness and low content of dampness in the rooms) for the session of morning, afternoon and evening. Figure 10 shows the process flow of the data collection by using Thermal Imager tool.

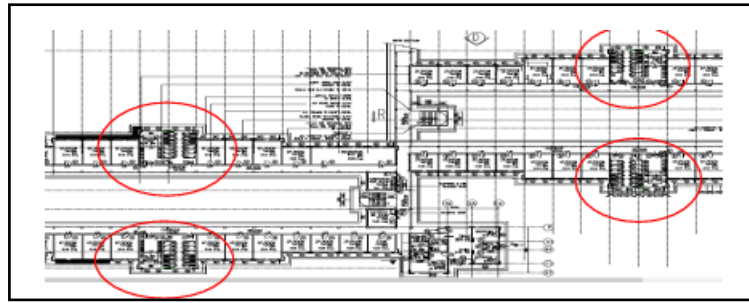
**Figure 11: Layout Drawing Based On An Observation Of And Student Rooms, Which Are Located Near The Toilet Areas**

For the first phase, it is important to perform visual observation during the field visit in order to identify the location of defects in the case studies. During this phase, two approaches will be used, namely condition survey using checklist and colour coding from a standard building condition rating known as Building Assessment Rating System (BARIS) and scientific tool, known as thermal imager device. Figure 11 shows layout drawing room which are located near the toilet areas and also case study.

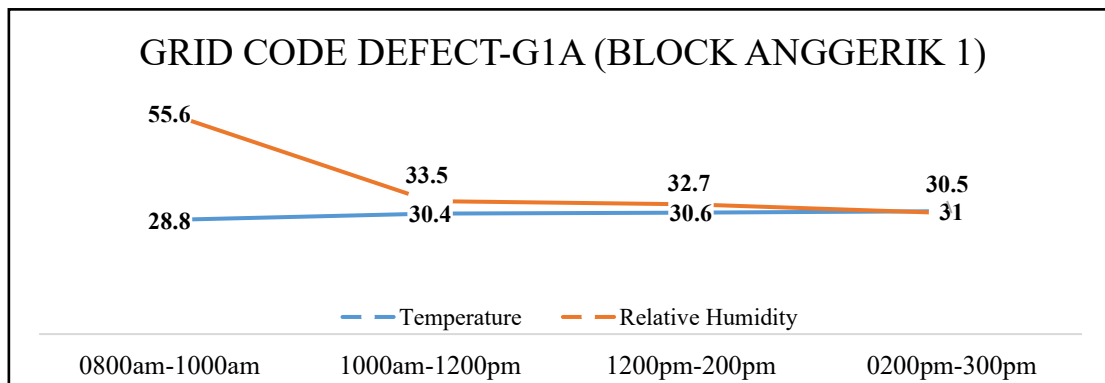
**Figure 18: Correlation between Temperature and Relative Humidity for Normal Range-grid code area-G1A**

For normal range readings at grid code defect area (G1A), the temperature is recorded between 28.8°C (morning session) which is 8.00 am – 10.00 am to 30.5°C (evening session) which is 200pm-300pm, and relative humidity (RH) is recorded between 15% (evening session) which is 200pm-300pm to 55.6% (morning session) which is 8.00 am – 10.00 am. The correlation data can be seen in Figure 18, where it indicates that when the temperature is lower (28.8°C), the RH % will be higher (55.6%) (Morning session) which is 8.00 am – 10.00 am and when the temperature is higher, the RH% will drop at 30.5% (evening session) which is 200pm-

300pm. It proves that the humidity in air is colder during the morning time which may accumulate the damp during this time.

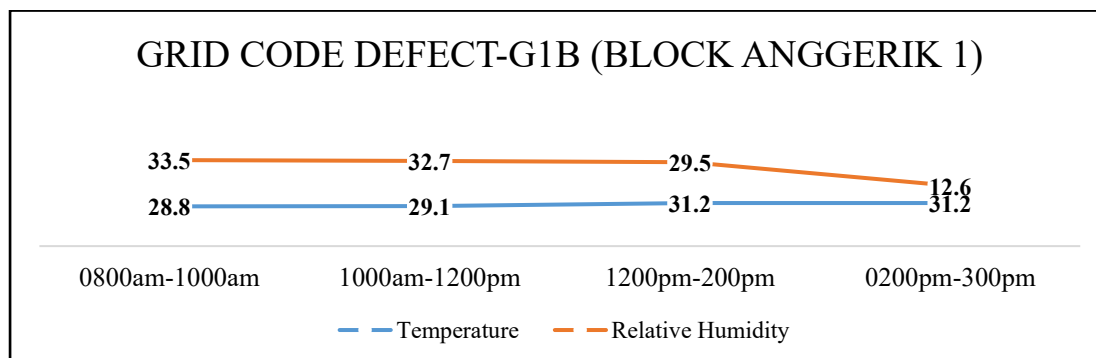
**Figure 19: Correlation between Temperature and Relative Humidity for Normal Range-grid code area-G1B**

For normal range readings at grid code defect area (G1B), the temperature is recorded between 28.8°C (morning session) which is 8.00 am – 10.00 am to 31.2°C (evening session) which is 200pm-300pm, and relative humidity (RH) is recorded between 12.6% (evening session) which is 200pm-300pm to 33.5% (morning session) which is 8.00 am – 10.00 am. The correlation data can be seen in Figure 19, where it indicates that when the temperature is lower (28.8°C), the RH % will be higher (33.5%) (Morning session) which is 8.00 am – 10.00 am and when the temperature is higher, the RH% will drop 12.6% (evening session) which is 200pm-300pm. It proves that the humidity in air is lower during morning time which may accumulate the damp during this time.
