**INTERNATIONAL JOURNAL OF  
INNOVATION AND  
INDUSTRIAL REVOLUTION  
(IJIREV)**[www.ijirev.com](http://www.ijirev.com)

**A REVIEW OF THE DAMPNESS-RELATED FACTORS THAT  
AFFECT BUILDING STRUCTURES. CASE STUDY:  
UNIVERSITY FACILITY BUILDINGS**

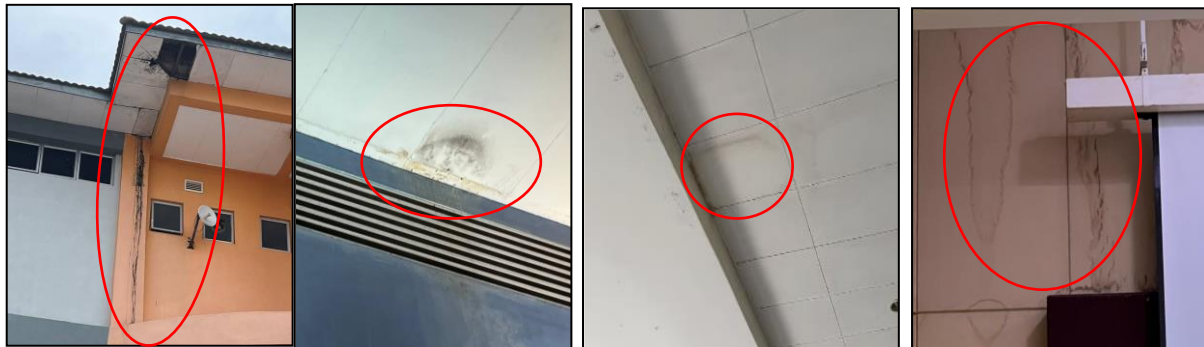
Figure 3 shows that water penetration was most common during rainfall periods. The roof leak occurred in the sports complex, library, and multipurpose building, resulting in water stain marks on the ceiling boards and walls. Poor installation or broken flashing around roof edges and valleys can lead to water ingress. The roof also broke down because of the extended dampness. It not only gives an unpleasant impression, but it may also endanger any person passing by the roof.

**Figure 3: The Dampness Symptoms Caused by Roof Leakage.**

As described in the findings section, the issue of ceiling moisture caused by roof leakage must be resolved. Frequent roof inspections, prompt repairs, good maintenance (such as gutter cleaning and providing sufficient ventilation), and the use of high-quality roofing materials installed by skilled specialists are all necessary for preventing roof leaks (Morgado et al. 2017). Immediate repair of roof problems is essential for maintaining the building's structural integrity and preventing water damage and mould formation in interior areas.

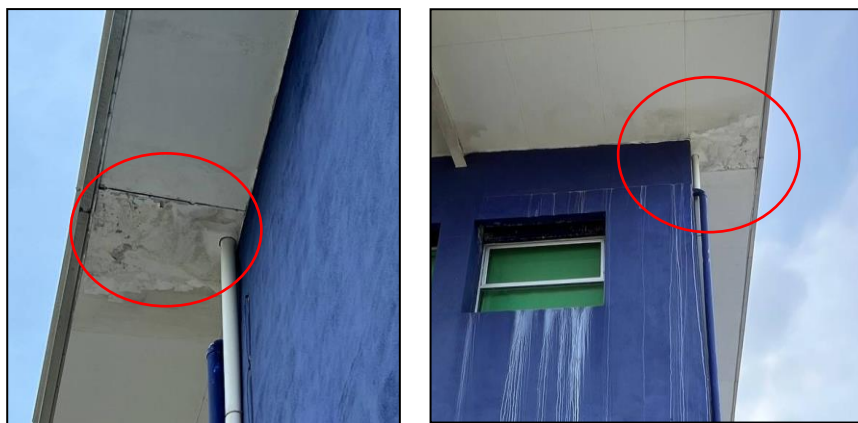
Figure 4 illustrates how a clogged downpipe on the roof led to water intrusion, allowing rainfall to flood over the ceiling or soffit. This scenario occurs at Sport Complex, where during rainfall, water collects on the roof's surface and runs down via the gutters to the downpipe for drainage. Debris like leaves, twigs, or dirt clog the downpipe, obstructing the normal water flow. This obstacle prevents water from draining properly down the downpipe and away from the structure. As the downpipe becomes clogged, water accumulates in the gutters. With nowhere else to go, water may overflow over the gutter's surroundings or back up onto the roof.

**Figure 4: The Dampness Symptom Due to Clogged Downpipes**

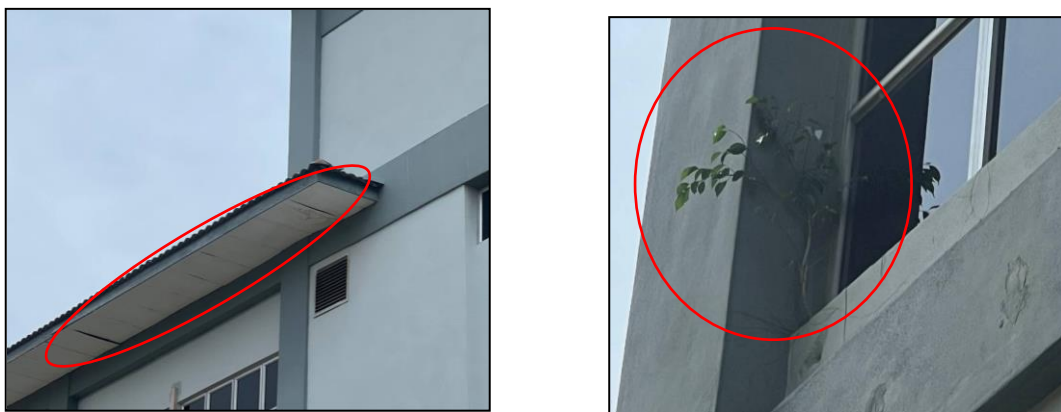
Stain marks develop on the library's fascia boards. Poor ventilation and insulation in roof spaces can lead to condensation. Condensation can accumulate in roof spaces, causing moisture and perhaps encouraging mould growth. Continuous condensation on ceiling or soffit surfaces can lead to moisture accumulation over time. Moisture can seep into ceiling or soffit materials, making them moist. Unwanted plant or vegetation growth is another indicator of dampness in the library. Moisture accumulated on building surfaces as a result of rainfall, condensation, or insufficient drainage, providing an excellent habitat for plant growth. Moisture can accumulate in cracks or poorly ventilated areas, encouraging plant germination and growth. This is shown in Figure 5.

**Figure 5: The Dampness And Vegetation Growth Symptom On Fascia Boards Due To Condensation Or High Moisture**

The next discovery is the stain mark on the soffit and vegetation growth caused by condensation. To avoid condensation, ventilation systems such as ridge vents and soffit vents should be improved to promote air circulation and reduce moisture buildup (Haverinen-Shaughnessy et al. 2008). Unwanted vegetation growth on structures can gradually cause damage to the building materials. Periodically cleanse the surfaces of the structure, gutters, and roof areas to eliminate biological material and prevent the collection of moisture (Morgado et al. 2017).

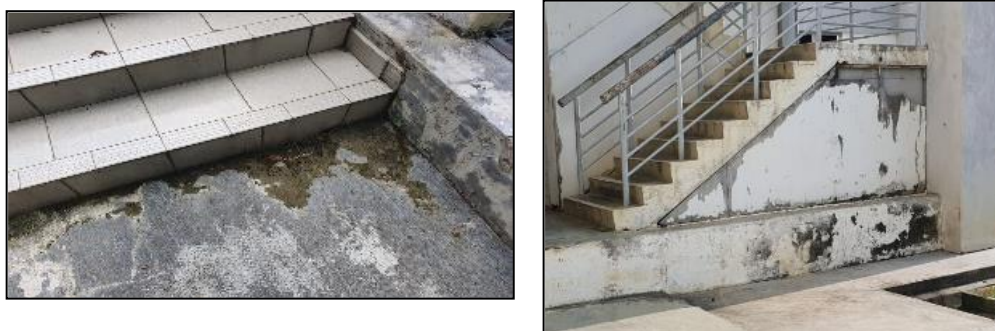
Staircases are subject to rainfall, which can result in water standing on the steps or infiltrating through cracks and joints, as shown in figure 6. The wind's energy causes this form of rain to fall horizontally or at an angle rather than vertically. Because of its powerful nature, driving rain can have a considerable influence on buildings and outdoor spaces, posing many problems and dangers. It takes place at the Pusat Islam and Annex buildings.

**Figure 6: The Standing Water and Mould Growth on Staircases**

Furthermore, it is necessary to deal with the issue of stagnant water on the stairs and the presence of water stains on the walls. Implement an appropriate slope and drainage system to effectively divert water away from the stairs. Perform routine inspections and maintenance on drainage systems to avoid the accumulation of water (Au-Yong, Ali, and Chua 2016). For the next design, architects should ensure that the roof slope is appropriate to prevent rainwater from standing on the floor and splashing on the wall.

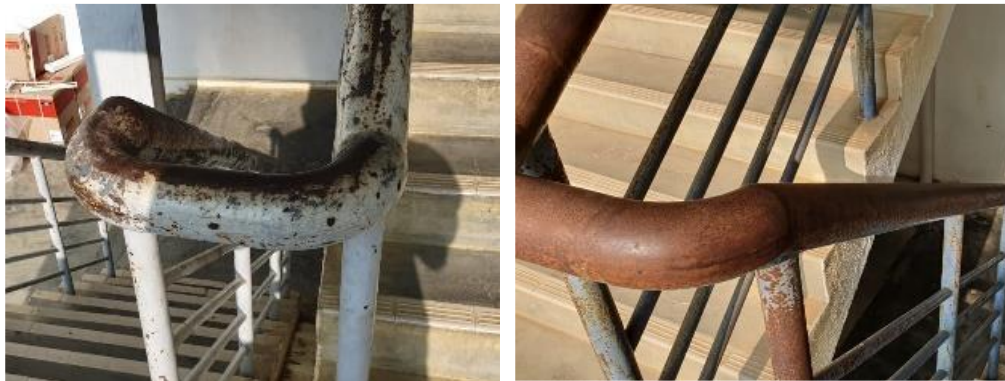
Figure 7 shows the deterioration of handrails due to corrosion. Staircases located in partially exposed areas are subject to dampness from rain and humidity. Extended exposure to water can lead to corrosion, particularly on metal handrails.

**Figure 7: Corrosion of Handrails Due to Dampness**

Another discovery is the degradation of railings caused by corrosion. Conduct regular inspections of handrails to detect any symptoms of corrosion and immediately act by cleaning, repairing, or replacing the affected portions. Universities can extend the lifespan of staircase handrails, assure user safety, and decrease maintenance costs by implementing proactive ways to safeguard and maintain them (Hauashdh et al. 2022), thereby mitigating damage caused by corrosion.
