THE SIGNIFICANCE OF PROPER COOLING TOWER WATER TREATMENT: A CASE STUDY

This paper presents the result of a study of the effect of cooling tower system in terms of performance and cost of maintenance. The study was conducted in a two-storey shopping complex building. Observation on site was held to obtain data on full load amp (FLA) and chilled water temperature (CWT) before and after servicing cooling tower unit. Energy of cooling tower were evaluated by analysis of FLA and CWT in percentage value. The condition on the system and component were also observed to differentiate the condition before and after treatment. The result obtained showed that cooling system performance after the treatment was increased.

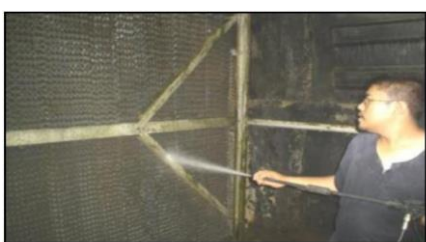
Figure 9: Cleaning Cooling Tower Fins

To overcome all the issues that occurred, servicing work was conducted to service at heat exchanger and cooling tower. Figure 7 and 8 below shows tubing cleaning in heat exchanger.

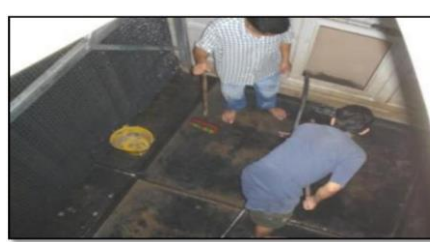
Figure 10: Cleaning Cooling Tower Hot Basin

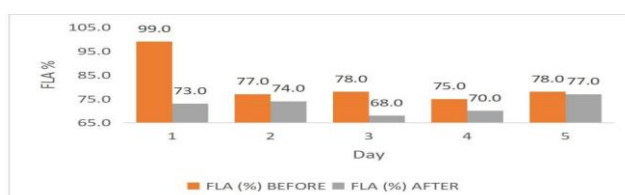
Figure 11 and 12 show the significant effect to the Full Load Amp demand and Entering Condenser Water Temperature after servicing heat exchanger and cooling tower cleaning was done. Full load amp (FLA) is the maximum current draw that a motor or equipment can take when running at full capacity. The current usage of a cooling tower is directly related to its energy consumption because the motor that powers the fan or pump consumes electricity and generates heat while running. Therefore, the higher the FLA of the motor, the higher the energy consumption of the cooling tower.

Figure 11 : Full load Amp

Furthermore, the current usage of a cooling tower can vary depending on the load it is currently handling. When the cooling demand is low, the motor may draw less current and consume less

electricity. Conversely, when the demand is high, the motor may draw more current and consume more electricity. ECWT also showed an improvement after the servicing process where there is a decreasing entering temperature value as in Figure 12. Therefore, understanding the FLA and current usage of a cooling tower can help to optimize its energy efficiency and reduce operating costs (Oliveira & Ukil, 2019).

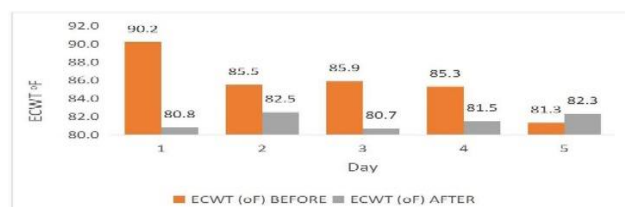
Figure 12: Entering Condenser Temperature (ECWT)
