# THE IMPACT OF CLIMATIC FACTORS ON DAMPNES IN UNIVERSITY ACCOMMODATIONS: A CASE STUDY ANALYSIS

Abidin, Z. Z., Ahmad, N. A., Rijal, N. S., Rased, A. N. N. W. A., Abdullah, W. N. H. W. (2025). The Impact Of Climatic Factors On Dampness In University Accommodations: A Case Study Analysis. *International Journal of Innovation and Industrial Revolution*, 7 (21), 240-260.

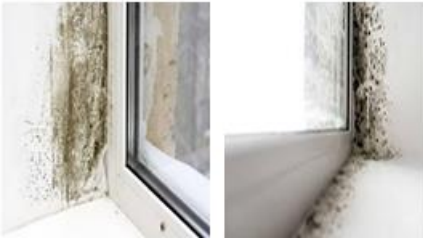
**Figure 5: Condensation Damp**

| | Condensation occurs when moist air comes into contact with a colder surface like a wall, window, mirror etc. The air can't hold the moisture and tiny drops of water appear. It also occurs in places the air is still, like the corners of rooms, behind furniture or inside wardrobes (Sustainable energy, 2013). | The only way of preventing condensation is to provide ventilation. The warm air, containing the water vapour, will rise and circulate around the room until it finds a cooler surface, unless we let that air out and some cooler air in (EPA, 2013; Seppanen and Kunitskin, 2009). |
