## GREEN MAINTENANCE FOR HERITAGE BUILDING: A PERSPECTIVE ON LATERITE STONES REPLACEMENT

**Abstract:** *The benchmark emphasised in research for the maintenance of heritage building had been vitally set to support a sustainability concept. The discussion revolves throughout the economic, societal and environmental parameters. Primarily, the low carbon repair had been given the main privilege in achieving sustainable repair and this was supported by 'Green Maintenance' concept and methodology. Previously, laterite stone replacement technique was recognised as a sustainable repair technique in terms of their embodied carbon expenditure over a number of repair scenarios, represented by the total Environmental Maintenance Impact (EMI). The total of EMI is calculated through formulaic expression within 'cradle-to-gate' boundary of Life Cycle Assessment (LCA). Hence, the goal of this paper is to explore and expand the practicality of laterite stone replacement technique utilised for heritage buildings located in Melaka Historical City, Malaysia, in the lens of 'Green Maintenance' concept and methodology. Subsequent discussion highlights the series of process incurred in conducting later

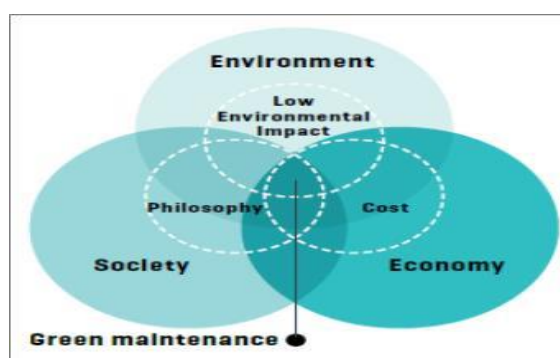
Figure 1: ‘Green Maintenance’ conceptual model  
Source: Forster et al., (2011), Kayan (2013)

Emergently, ‘Green Maintenance’ concept envisioned by Forster et al., (2011) draw a generally accepted model of sustainable development to gain a consistent measurement; society, economic, and environmental (Kayan et al, 2016) and subset of these parameters described that any evaluation of maintenance intervention should be based on conservation philosophy, cost and low environmental impact (see Figure 1). Therefore, any intervention that interlaid with these three parameters will be considered as most sustainable repair. However, the evaluation of environmental impact of maintenance is being ignored in academia alike (Kayan, 2013). It is observed that the efforts of the current assessment and tools given for maintenance and repair are concentrated on dilapidation survey, laboratory test and isolated field studies (Kamaruzzaman et al., 2011) or often reduce to the building-retrofitting decision specifically to improve the mechanical systems [energy efficiency] (Margini and Franco, 2016). Meanwhile, the current precedent scheme on Green Building Rating (GBR) i.e. Green Building Index has suffered a lack of universality in order to calibrate into the actual performance of maintenance and repair of heritage buildings (Cabeza et al., 2013). It is important to note that any installations of modern equipment and tools to boast their energy efficiency were often incompatible, unfeasible and the payback of the energy consumption is always questionable (Young, 2011). It is clear that deficiency of old buildings to perform as a new building in term of their energy performance due to several restrictions; construction technique, typological and functional features (Loron et al., 2015). However, Forster (2016) stressed that the natural remedies are already served on their maintenance and repair, therefore need to be progressed as heritage building has almost innumerable tonnes of embodied carbon locked up in its fabric and there is much can be learnt from the existing restrictions. In this case, Forster et al., (2011; 2013) raised the vital role to promote a low environmental impact of maintenance and repair through embodied carbon expenditure. Embodied carbon is principally defined as CO<sub>2</sub> emissions released through the process of extraction, manufacturing, transportation of materials that consume a fair amount of energy in terms of electricity and fuels in maintenance and repair (Giesekam et al., 2016).

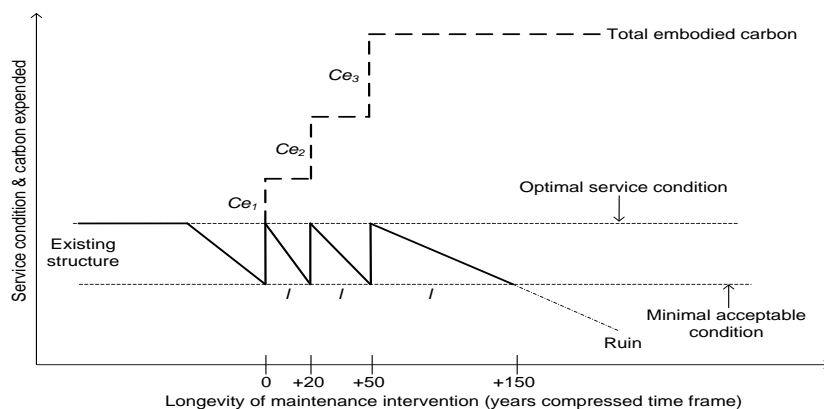
**Figure 2: Relationship between longevity of repair and embodied carbon expenditure**

Theoretically, the correlations between CO<sub>2</sub> emissions are associated with the number of repairs, repair type, and material usage as well as longevity of repair (frequency of repair) illustrated in represented in Equation 1 and Figure 2 (Kayan, 2015). Figure 2 shows the implication on undertaking maintenance and repair characterised by its longevity ( $I$ ) and embodied carbon expenditure ( $C_e$ ) in the service condition of heritage buildings over time. The downward sloping signifies the decline condition of the building where each intervention is important to keep the buildings at the optimal service condition, however contributed to a significant amount of CO<sub>2</sub> emissions through material requirements and procurement (extraction, manufacturing, and transportation of material). Hypothetically, the more frequent of maintenance intervention, the greater embodied carbon expended (Forster et al., 2013). Commonly, preference is given to repair technique with higher longevity that subsequently incurred a lesser number of repeated interventions and lesser-embodied carbon expenditure. Emphasised that there are another variables that should be considered; resourcing location, a degree of exposure, building detailing, mode of transportation, technological development, quality of work and design specifications (Kayan, 2015). Noted here also, there are numerous mechanisms suggested in this concept and methodology to attain the reduction of CO<sub>2</sub> emissions in maintenance and repair such as usage of locally sourced repair materials, engagement of companies to undertake repair work and selection low embodied carbon (Kayan, 2013).

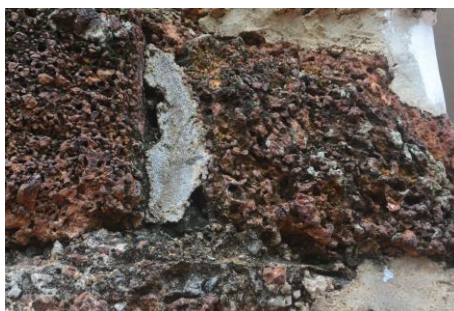
**Figure 4: Laterite Stone**  
Source: Author (2017)

Laterite stones (see Figure 4) have become the subject of controversies due to its nature of formation and genesis of lateritic materials (Paramanathan and Tharmarajan, 1983). Generally, the formation of laterite was perceived as product of weathering (metasomatic rock) in 1800 and in the middle of the twentieth century, the attention had been focused on geochemistry of weathering (dry and wet condition) and suitable geological condition i.e. plateau with varying alluvium character and topography that influenced the chemical laws or known as laterisation in soil (Ahmad and Hoe, 2002). Many hypotheses have been advanced to essentially differentiate the weathering processes exhibit by the rocks and laterisation in a soil. However, the differentiation is only revolved the unique process in achieving a specific mineral and chemical content (Fe<sub>2</sub>O<sub>3</sub>, SiO<sub>2</sub> and Al<sub>2</sub>O<sub>3</sub>) that is enhanced by climate condition (repetitive wet and dry season) to speed up the leaching process (Pendleton, 1941).

The aforementioned processes are also associated with the physical appearance of laterite stones. Physically, laterite stones is manifested as spongy coarse, ferruginous rough material varying in colour from white, yellowish, rusty red to liver colour, brown material or almost black with lilac-tinted lithomarge earth depending on the mineral and chemical content such

as ferrous iron, aluminium, kaolinite clay that is also known as sesquioxide content formed in the hot and wet tropical area (Adekunle et al., 2014). For example, a whitey colour of laterite occurred due to the domination of kaolinite clay and red for ferrous iron. The content has made laterite stones as a unique building material; soft material until it can cut using a spade to be made into a regular block and harden after exposure (Noronha et al., 19998). It is mainly due to the reaction between sesquioxides content and air exposure, which enhances a good bond with other particles, known as oxidation process (Varghese, 2015). As a building material, the accumulation of sesquioxides will influence the method of the extraction, appearance, compressive strength and porosity as important criteria selecting compatible material for repairing heritage building (Historic Scotland, 2014). Broadly, laterite stones offer a good strength and durability as building material showed by numerous heritage building that now still stands over the worlds through conflicts and with the test of time under tropical hot climate.

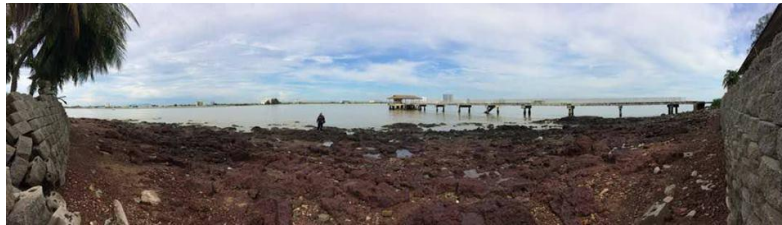
**Figure 8: Laterite Stones at old quarry of Pulau Upeh, Melaka**  
Source: Author (2017)

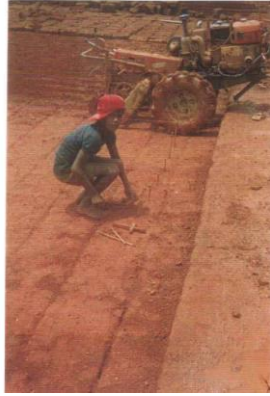
**Figure 10: Marking lines process on the top of laterite soil in Goa, India**  
Source: Noronha et al., (1998)

Based on the previous discussion, it is important to aware that the formation of laterite is incurred in either soil (plinth) within pallitic zone or the large boulder of laterite rock. Reported by JWN (2008) that laterite from Pranchiburi, Thailand is formed within the soil. In Pulau Upeh on the other hand, the large number of laterite beds were found abundant over the island, where it is locally known as Pulau Batu before (JWN, 2002). To obtain laterite, first, overburden removal needs to be done at least a foot or more below water-table as it getting wet and softer with depth and may offer excellent quality for all purposes (Noronha et al., 1998). For the large bed of laterite (laterite boulder) is nearly undisturbed, only the loose materials are removed from the surface (Pendleton, 1941). After the surface has been smoothed off either manually removed by hand, dozer or hydraulic shovels, usually the levelling process will be taken immediately to determine the horizontal bed of laterite and marking a line using manual measurement equipment [see Figure 10] (Kasthurba et al., 2014). In Pulau Upeh, it is found the similar dimension of size ranging about less than 600 x 300 x 300 mm of blocks. This indicates that the measurement of stone had been precisely done on the site (in situ) to built Melaka Fort. In which, no secondary cutting has occurred.

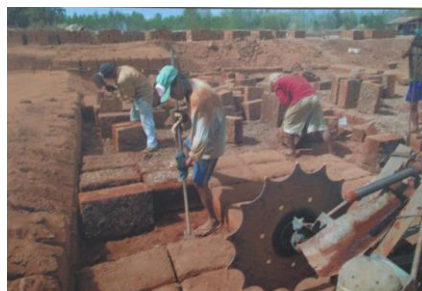
**Figure 11: Cutting processes of laterite stone in Prachiburi, Thailand for Bastion Middelburg**  
Source: JWN (2008)

Laterite then will be cut into square blocks through the lines marked and desired depth. To date, the use of machinery for quarry known as a cutter with tungsten carbide bits or mechanised mobile rotatory saw (see Figure 11) in the last decade resulted in large-scale of production of laterite and reduce the wastages to meet the growing demand (Kasthurba et al., 2007). However, in practice, the wastage of laterite will be stored as a rubble stones (Noronha et al., 1998). In the past, any iron instrument is used to cut and dig up into square masses to the thickness of the blocks with a pickaxe and immediately cut into a shape by using a trowel or large knife [see Figure 12] (Pendleton, 1940). The evidence is also found in Pulau Upeh, Melaka where it had been cut smoothly about more than 2 inches, parallel to the usage of pickaxe (Figure 13). Whereas, for laterite formed in a soil, the characteristic of laterite is ranging depend on their depth. Pendleton (1952) suggested on digging up to approximately about 50cm in Ceylon and few centimetres to 180cm from the top of a soil in Thailand. Meanwhile, Kasthurba et al., (2014) reported on 520cm or to the depth of 25metres in Goa and Malabar region in West India. The depths of cut will determine the capacity of water absorption that subsequently will influence the compressive strength and density of laterite stones (Kasturba et al., 2007). It is proven that the usage of laterite stones for the heritage buildings in Melaka that is sourced from the seacoast area with considerable dimensions is a part of the valuable knowledge of Portuguese's stonemason thread. The maximum thickness is also found near to seacoast area (water access) in Malaysia (i.e. Tanjung Dahan and Pulau Upeh). On top, throughout the process, laterite stones need to expose to turn the material into a hard block, either in situ or transported to the storage location (Adekunle et al., 2014).

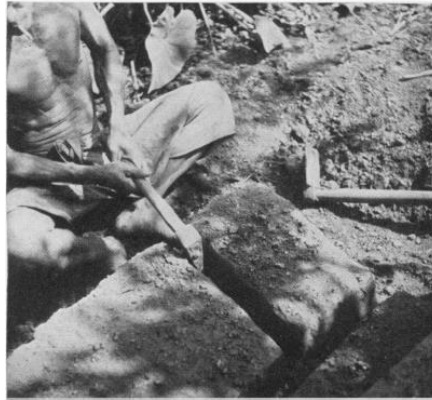
**Figure 12: Manually cut laterite using pickaxe in Chanburi, Thailand**  
Source: Pendleton (1940)

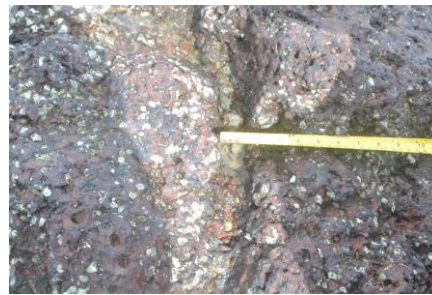
**Figure 13: Laterite stone-cutting scar in Pulau Upeh, Melaka**  
Source: Author (2017)
