## GREEN MAINTENANCE FOR HERITAGE BUILDINGS: LATERITE STONE REPAIR APPRAISAL

**To cite this document:** Halim, I. A., Kayan, B. A., & Mahmud, N. S. (2018). Green Maintenance for Heritage Buildings: Laterite Stone Repair Appraisal. *Journal of Tourism, Hospitality and Environment Management*, 3(10), 1-20.

**Abstract:** Maintenance is widely accepted as important mechanism for survival of heritage buildings. Progressively, their maintenance had shift towards sustainability, encompassing economic, societal and environmental domain. Meanwhile, the efficiency of maintenance and repair for heritage buildings is no exception and also conforms to these broad domains. Moreover, previous works and study on their repair appraisal within environmental domain garnered little attention. Emergently, low carbon consideration for heritage buildings became increasingly important in achieving a sustainable repair and this was supported by 'Green Maintenance' concept and methodology. Primarily, the aim of this paper is to gives insight on how 'Green Maintenance' has capability to evaluate low carbon repair for laterite stone structure, based on selected case studies of Bastion Middleburg and St Paul

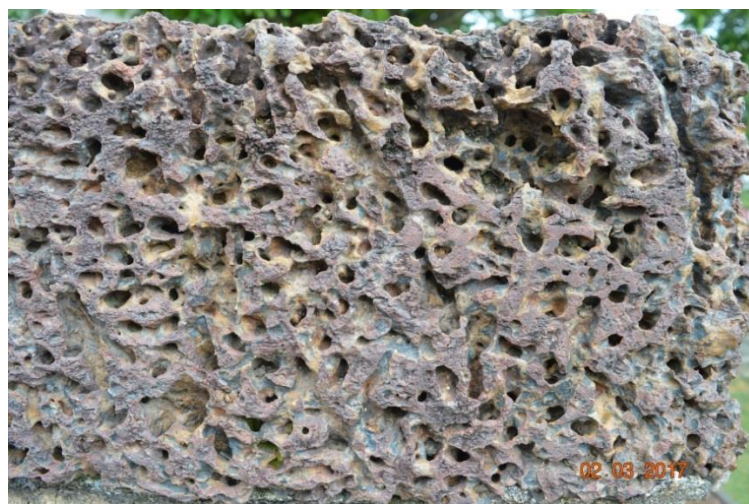
Historically, the bastion constructed mainly using rich of iron and alumina materials of laterite stones (JWN, 2008) (Figure 4). Archaeological evidences also show that, the Portuguese had built the bastion using locally sourced laterite stones from nearby quarries of St. Paul Hill, St. John Hill, Pulau Jawa, Pulau Upeh (Figure 5) and other several islands around Straits of Melaka (JWN, 2010). To date however, not only due to shortage of supply of laterite stones, there is also no active stones quarry in this area, mainly because of their closure (Ibrahim, 2007). Therefore, over the years, Bastion Middelburg repair is constantly facing difficulties, particularly in finding the locally available of original laterite stones; make them rare in terms of materials used. Based on relevant and currently available records, reconstruction works of the Bastion Middelburg, using laterite stones, cemented with concrete and mortars (Figure 6) only has been officially started in November 2007, and has taken about one year to complete (JWN, 2008).

**Figure 4: Bastion Middelburgh, Melaka, Malaysia-laterite stones**

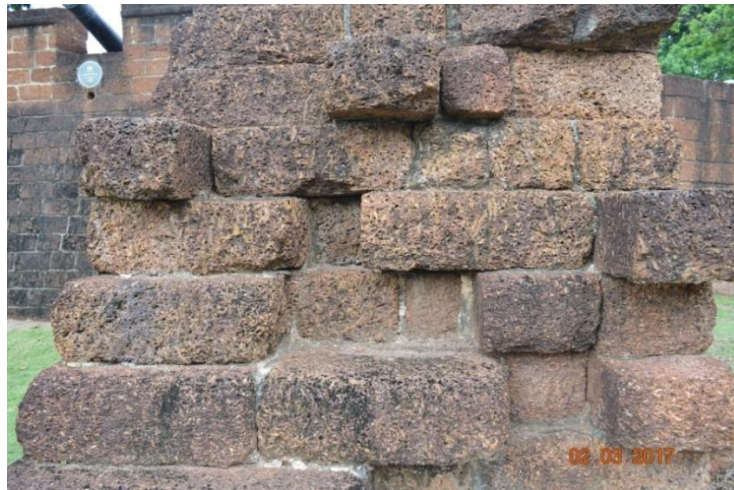
**Figure 6: Bastion Middleburg, Melaka-laterite blocks, cemented with concrete and mortars**  
Source: Authors, 2018.

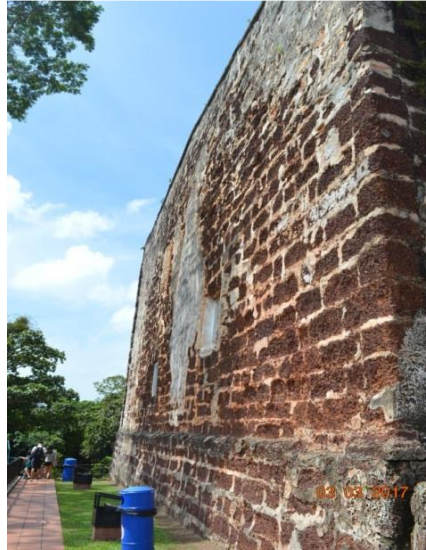
was hundred feet tall to its pyramidal roof. It was reinforced at ground level central pillar. Uniquely, the Portuguese used originally local laterite blocks. It is common that laterite stones were cemented by concrete and mortar, which was suitable for building solid, massive laterites walls (Figure 7) which could withstand attacks from enemies i.e. as a fortress as well as its distinctive nave and interior of laterite stones (Figure 8).

**Figure 7: St. Paul's Church, Melaka-solid and massive side laterite walls**  
Source: Authors, 2018.

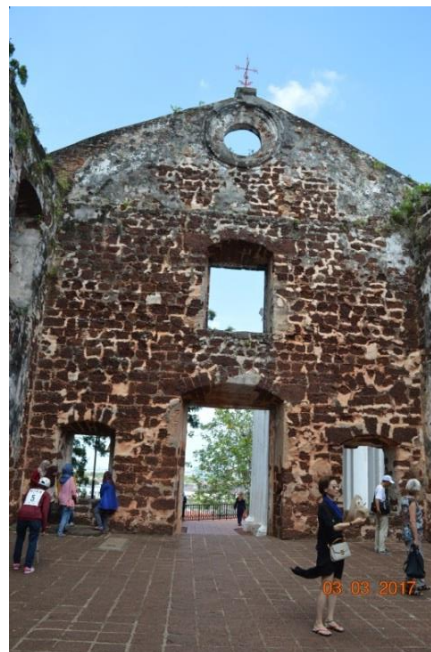
**Figure 8: St Paul Church, Melaka-distinctive nave and interior of laterite stones**  
Source: Authors, 2018.

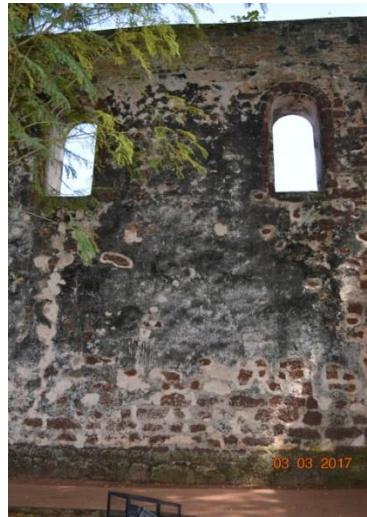
On the other hand, the basic construction tools available at the time in fact led the Portuguese to denote to laterites as 'iron stone'; such was their difficulty in cutting and dressing it. Due to necessity, couple with Melaka's seaside location (see seaward wall of laterite stone materials in Figure 9 and Figure 10), had caused the Portuguese to repair the church with easier to shape coral rock as a filler between the laterite, over the years. Based on historic and previous maintenance records, the laterite was carried from Pulau Upeh as well as from Cape Rachado

**Figure 9: St. Paul's Church, Melaka-seaward wall of laterite stone materials**

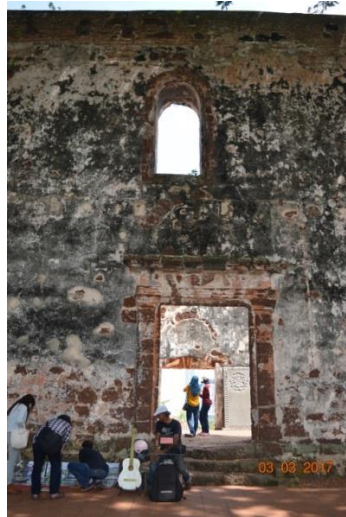
**Figure 10: St. Paul's Church, Melaka-detail of side door frame on seaward side wall using laterite stones**

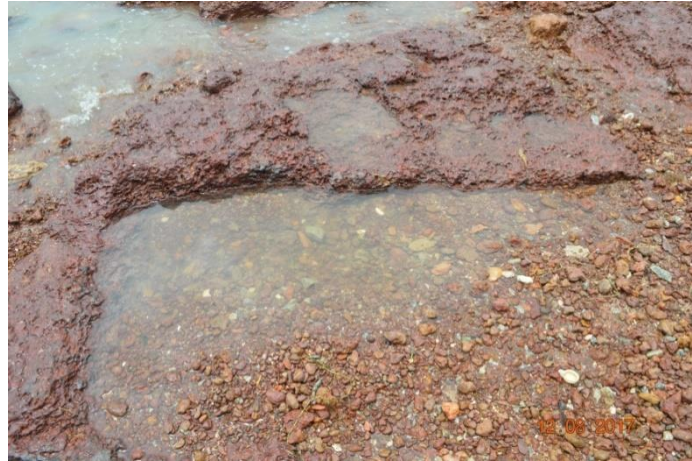
(Khoo, 1998). Remarkably, the traces of abandoned laterite stones quarry at Pulau Upeh remained to this day (Figure 11). Significantly, after the Dutch 1606 siege, the church's tower is long painted white. Remarkably, the function of the tower (Figure 12) is not only to aid navigation of ships, but also function as a much military turret as a civilian belfry (tower). Astonishingly, according to one of the earliest post-war Dutch maps, produced in 1656, the building at one time has been converted into a hospital. However, over the centuries, this building has also been adapted re-use as partially military function, which signifies usage of strong materials such as laterite stones as the main materials for its construction.

**Figure 11: The traces of abandoned laterite stone quarry at Pulau Upeh**  
Source: Authors, 2018.

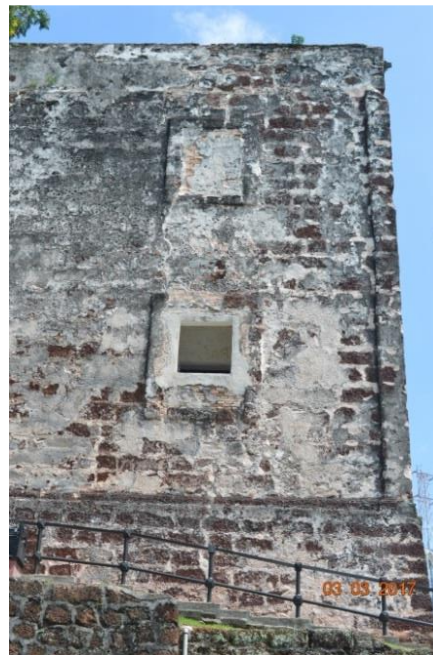
**Figure 12: St. Paul's Church, Melaka-view of church towards side of former tower using laterite stones**  
Source: Authors, 2018.
